S1017 Y- Strainer Cleaning Procedure

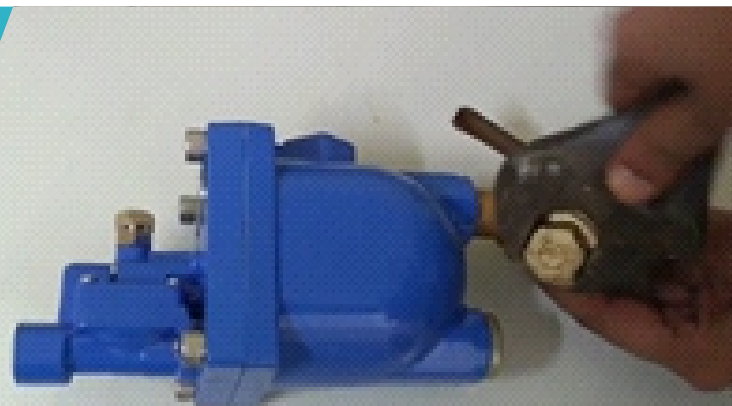
Open the Filter of Y-stainer gets choked by rust

Before servicing, ensure isolation valve - upstream of ADT - is closed

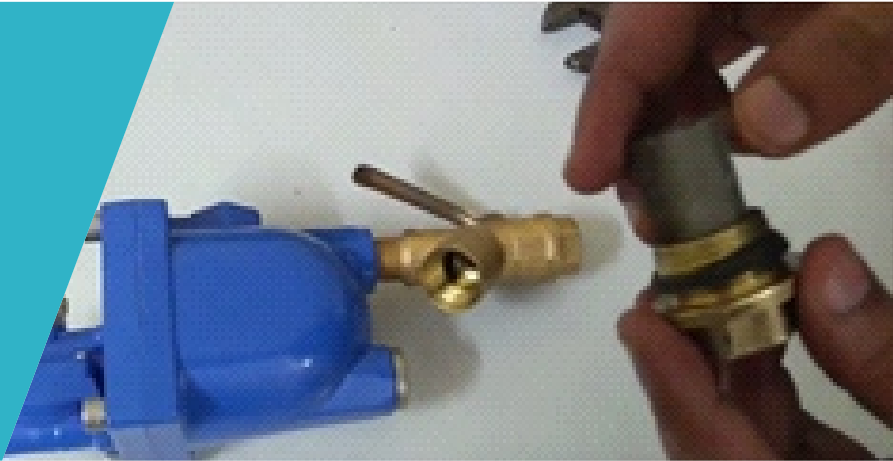
Remove Filter element

- Clean element using Air (if dust has accumulated) or Oil (if rust is noticed)

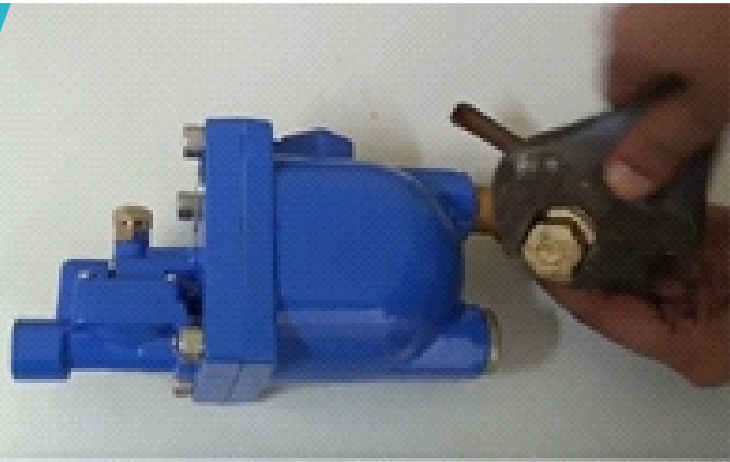
After cleaning, put the filter back in Y-Strainer and tighten using spanner

- Open valve for operation
